CHAPTER II

GEOLOGY, STRUCTURES, AND MASS-MOVEMENT IN

MAE MOH MINE

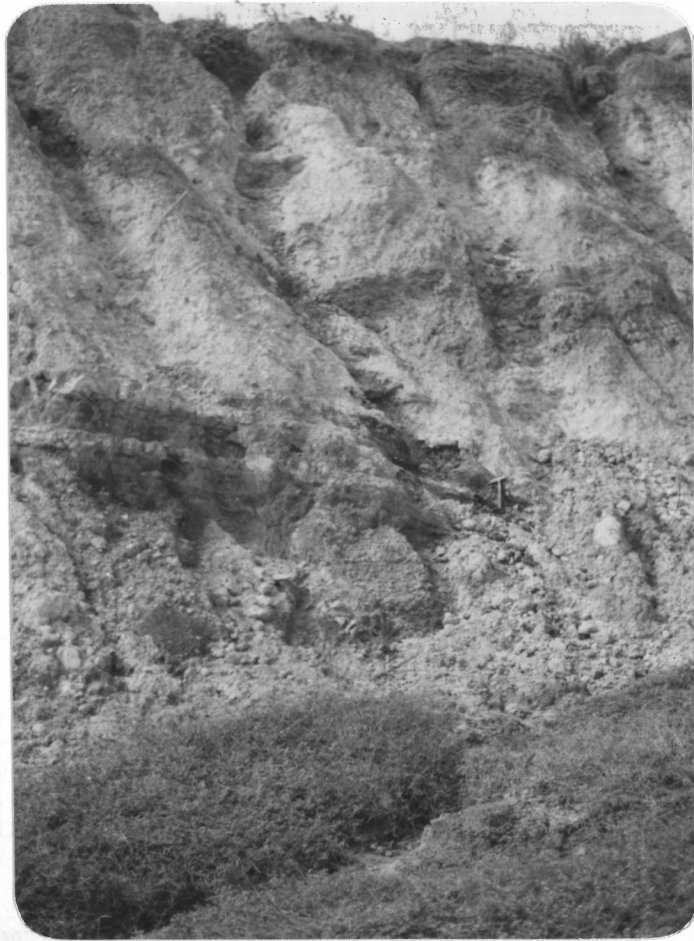
The weathering process was more significant on the slope face where the water flows over, than just under it (Figure 8).

Figure 8. Weathering process in the upper part of
northwestern flank slope in Subarea 3.

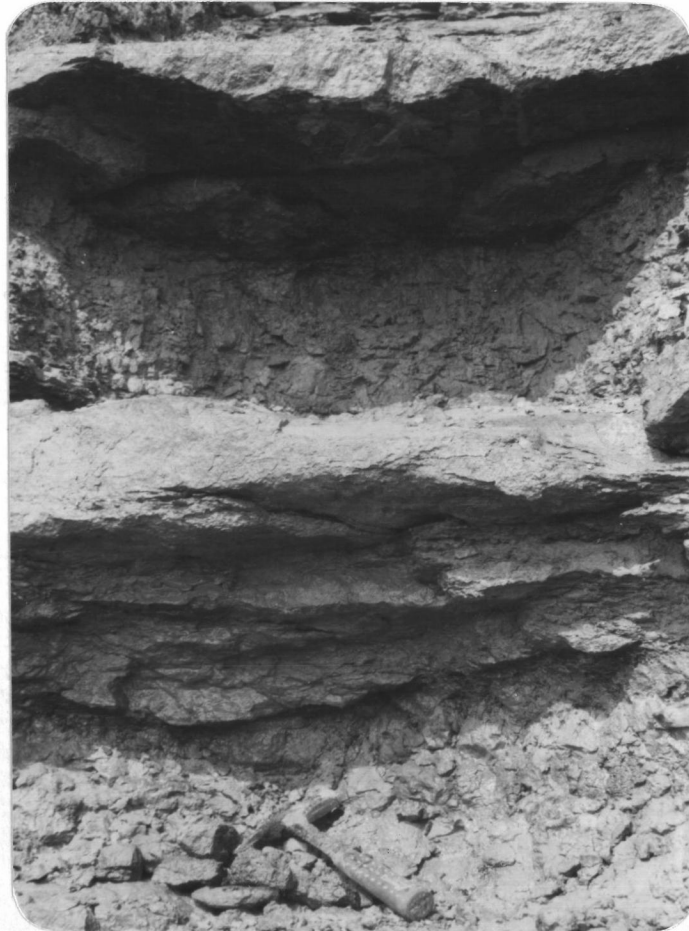
Figure 9. Selective weathering in Overburden Claystone.

The materials are classified as slightly to moderately weathered claystone.

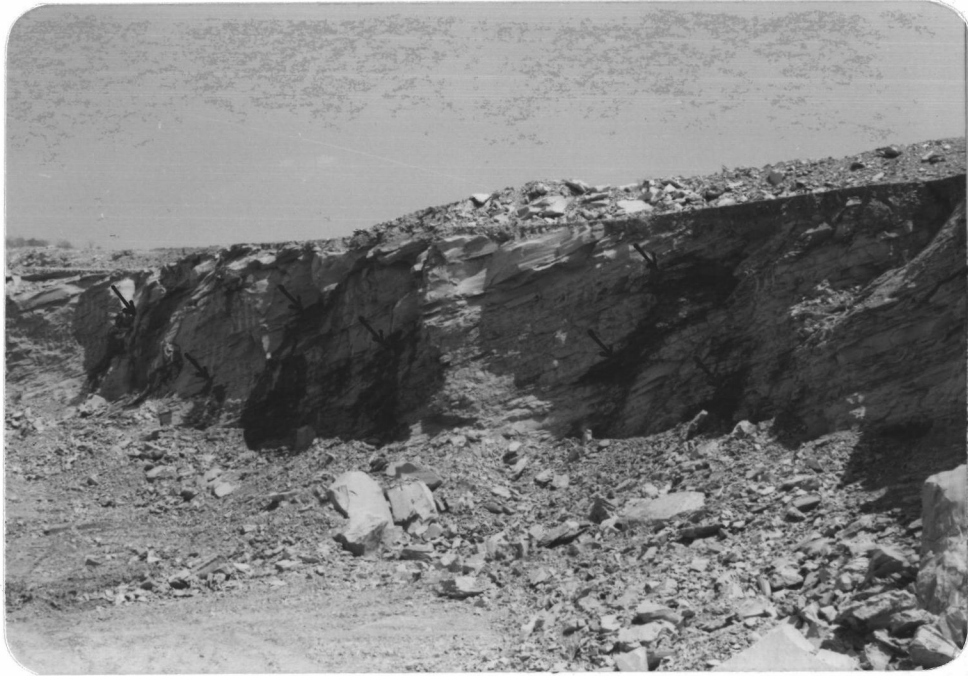
Figure 10. Water seepage along bedding in Subarea 5 (at the arrow).

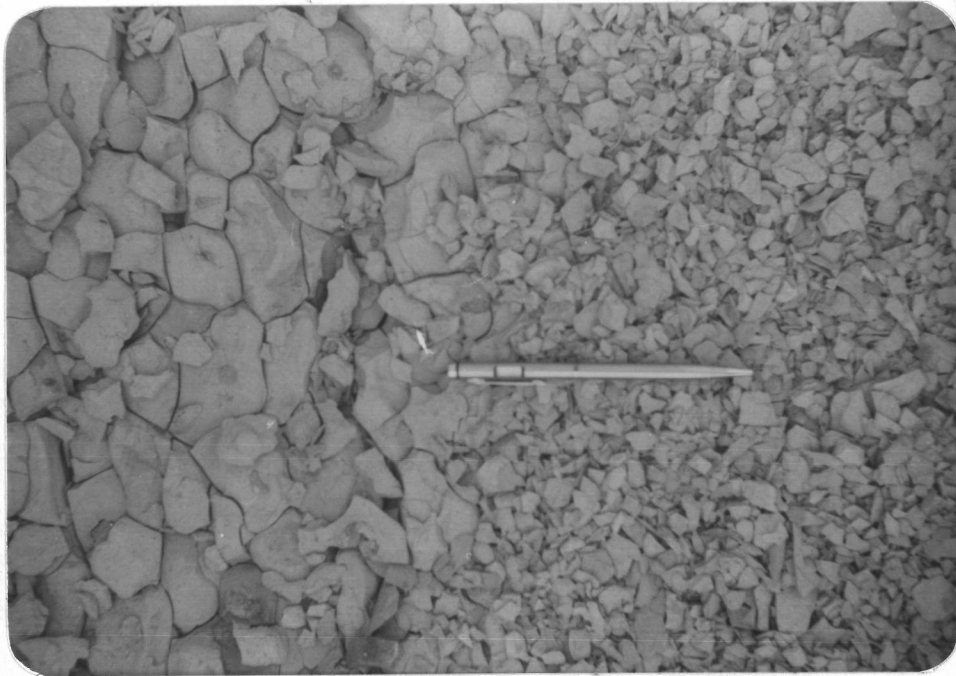
Figure 11. Weathering chips on bedding planes of claystone in Subarea 5.

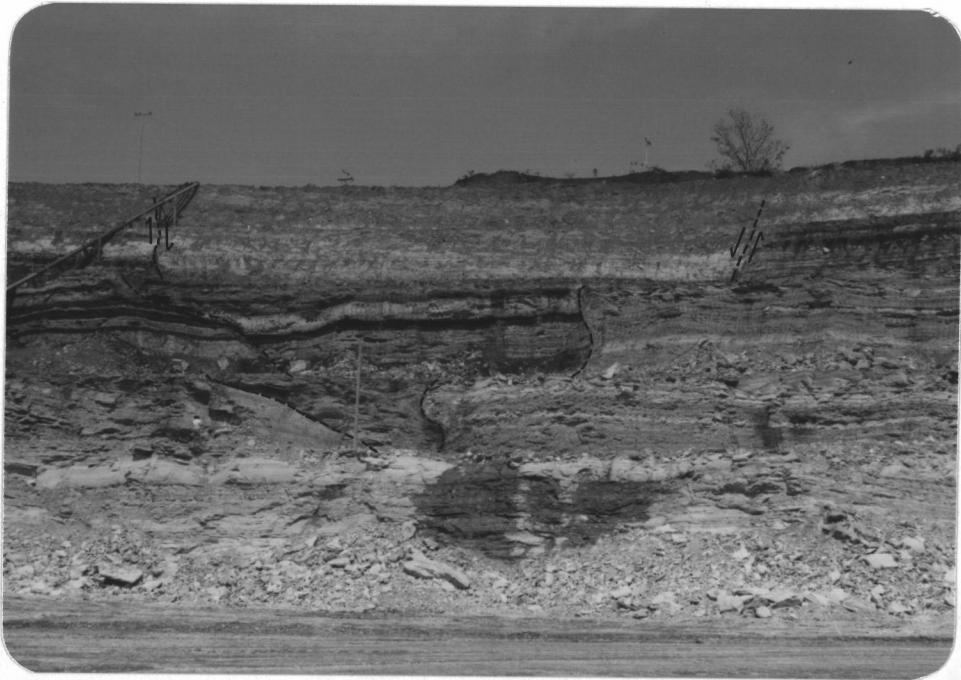
Figure 14. The northwestern flank slope of Subarea 4 showing a graben bounded by two normal fault planes.

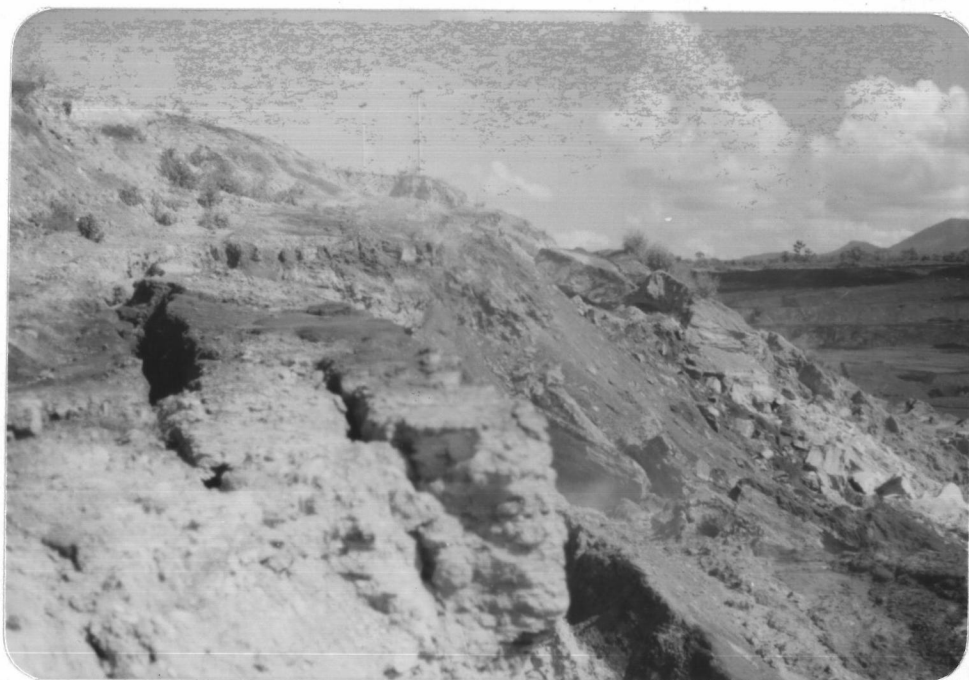
Furthermore, the decomposition of rocks because of the self-combustion of the lignite beds may also contribute to the decrease of strength of the slope materials (Figure 15).

Figure 15. The decomposition of rocks caused by the self-combustion of the lignite beds.

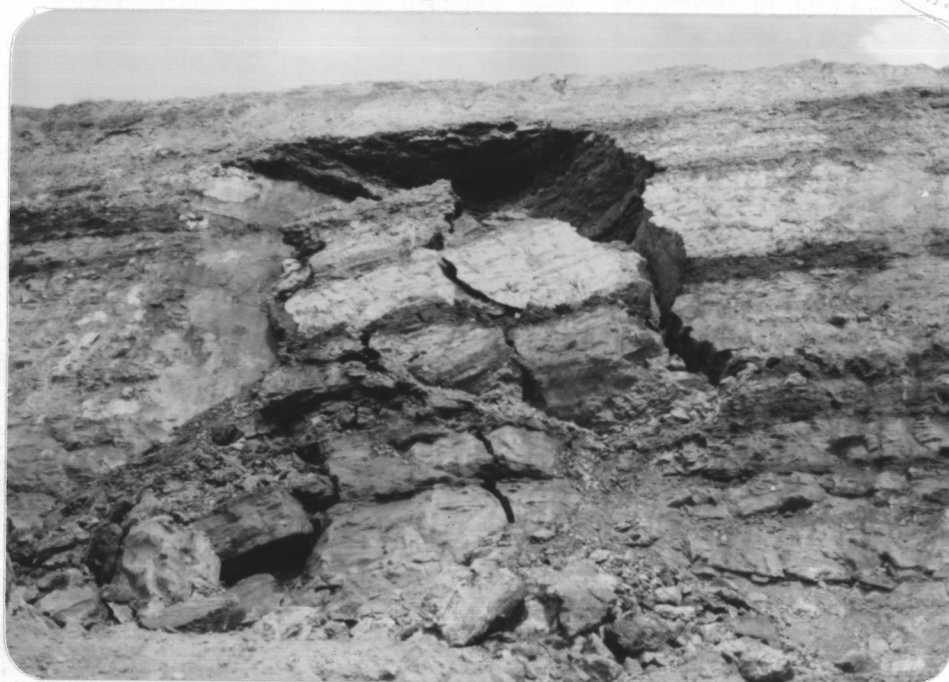
The first failure of the cut slope was recorded in the March, 1980 by Pramote Pornrattanapitak (1981, personal communication). The failure was of wedge type and only occurred on the lower bench (Figure 16). The wedge was controlled by the intersection of a fault striking 341° azimuth and dipping 35° NE and an irregular vertical joint striking 108°

Figure 16. Local wedge failure of the northwestern flank slope in March, 1980.

azimuth. The wedge was about 18 m high and 20 m long.

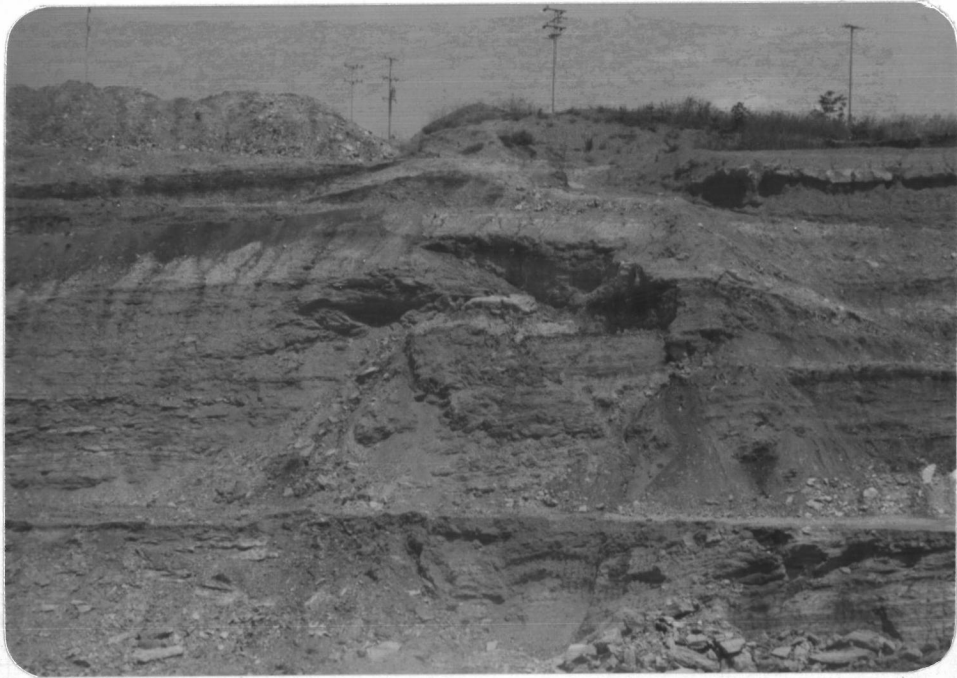
The wedge grew larger in the second failure recorded in March, 1981 by the author. Further sliding was also along the intersection line previously mentioned (Figure 17). This movement is the results of a higher degree of weathering by means of the alternating wet and dry season.

Figure 17. Enlargement of wedge failure of the northwestern flank slope (Figure 16) in March, 1981.

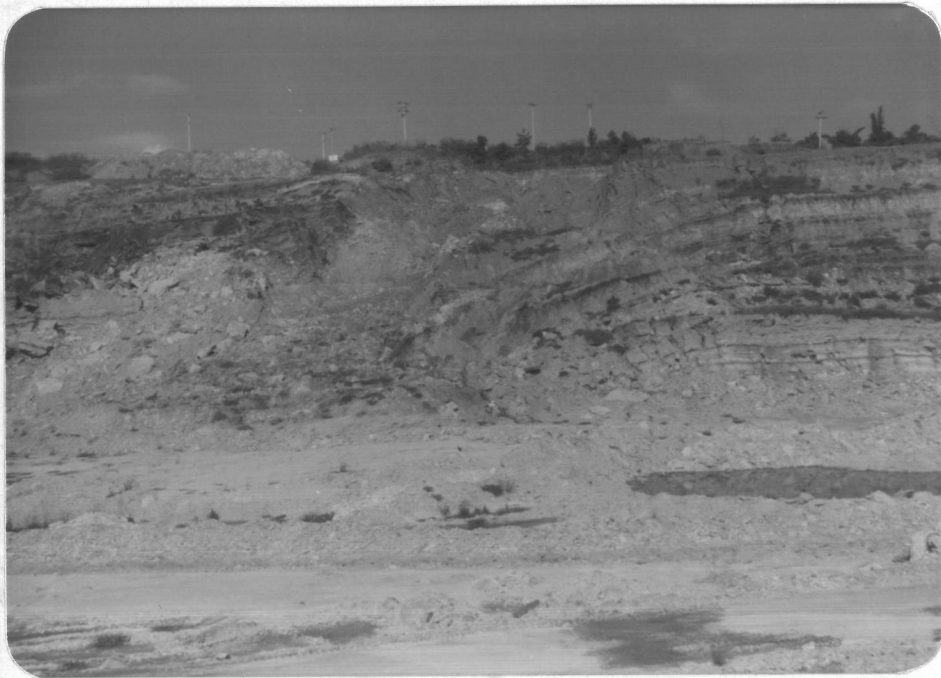
The movement of the landslide in this subarea is mainly controlled by the seeping rain water action which occurred during May to October.

In early July 1981, two tension cracks, about 55 and 30 m long respectively, were observed. The fractures were sub-parallel to the slope trend. They were probably the result of the stress release and tend to detach the upper part of the slope. When the meteoric water seeped into the slope mass along these cracks, the total weight increased, so was the driving force.

In early August 1981, during the period of heaviest rain, a major landslide took place covering an area of about 200 by 80 square meters (Figure 18). Plate III shows the distribution of landslide materials and the type and course of sliding.

Figure 18. Landslide of Subarea 3 in August, 1981.

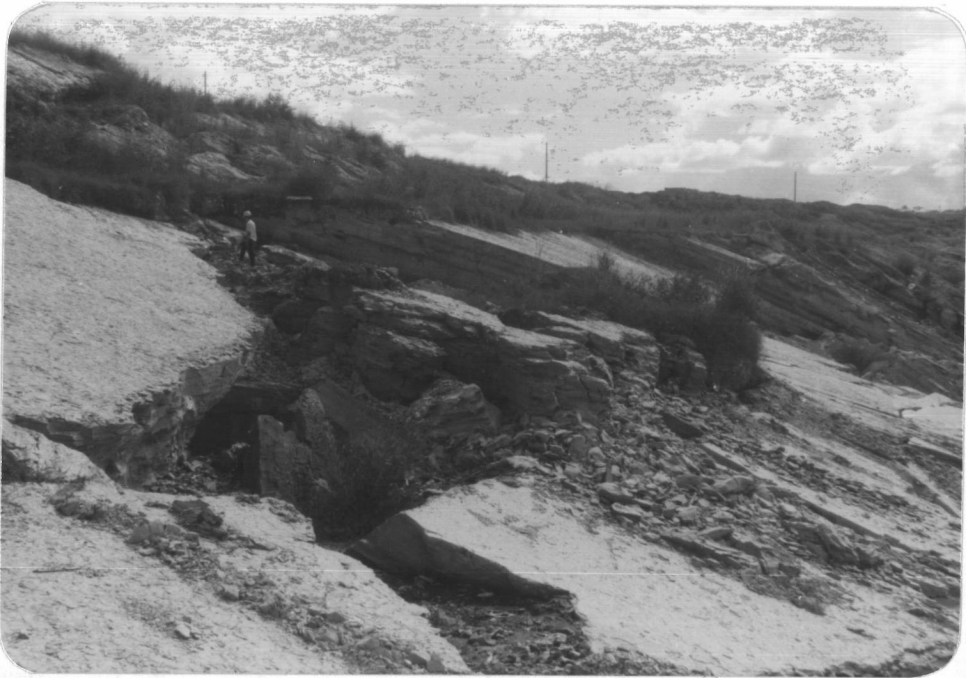
Planar bedding-plane sliding is found in the place where the dip of slope and of bedding plane are in the same direction. The sliding occurred when the blocks of upper strata are loosely bond to the underlying strata. This phenomena is largely effected by water action mentioned in previous section. Such slope movement occurred primarily in Subarea 5 (Figure 19).

Figure 19. Planar sliding in Subarea 5.

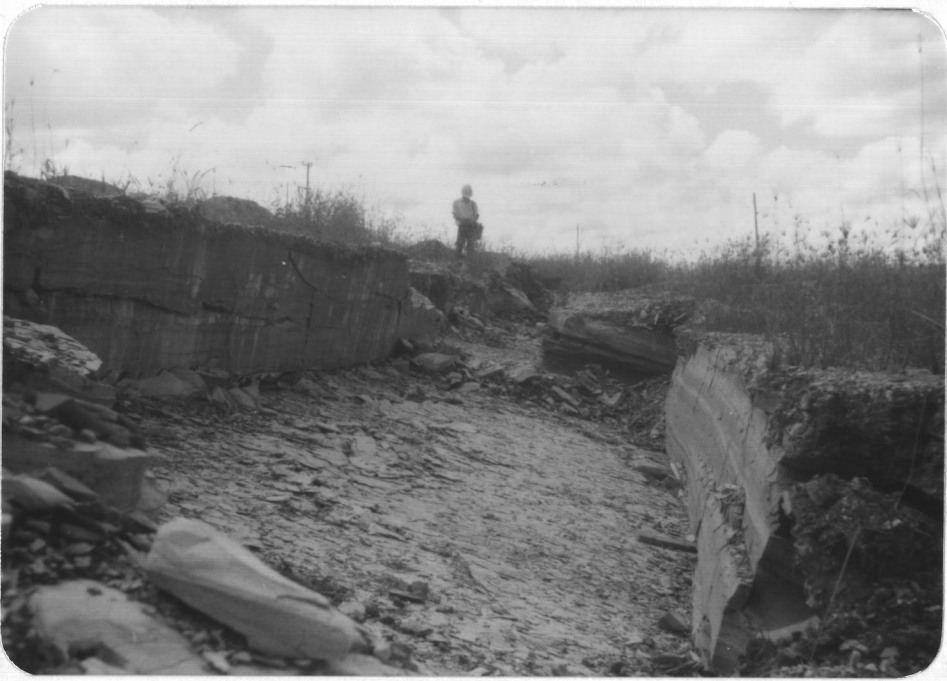
Joints which cut perpendicular to bedding plane play an important role by allowing the sliding and at the same time mark the limit of sliding blocks in term of length and width (Figure 20). The joints are of 2 sets, one is approximately parallel to the slope trend and the other cross-cut the slope and is almost perpendicular to the first set. The dip of the two joint sets is very steep to vertical.

Figure 20. Separation of joint due to block slide in Subarea 5.
