BRIDGE DECK DETERIORATION ASSESSMENT BY NONDESTRUCTIVE TESTING METHODS

A Thesis Submitted in Partial Fulfillment of the Requirements
for the Degree of Master of Science in Earth Sciences

Chulalongkorn University

Academic Year 2019

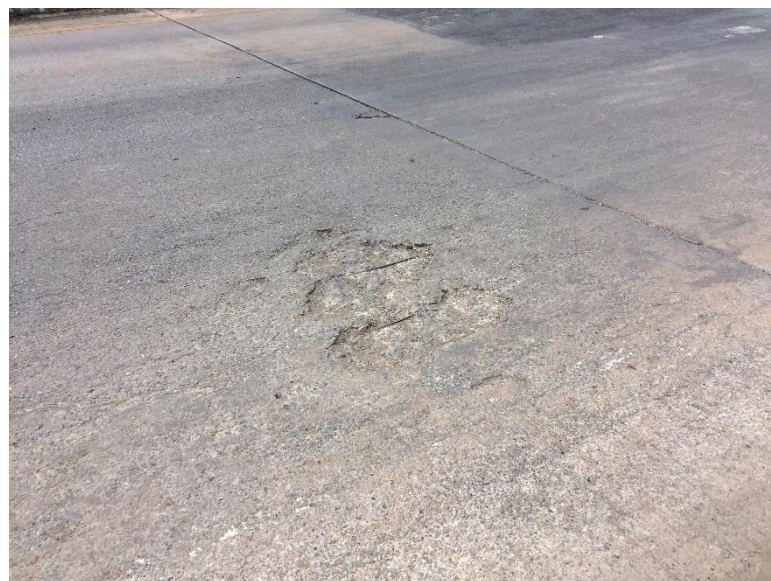
Figure 13 Concrete spall until reinforcing steel level

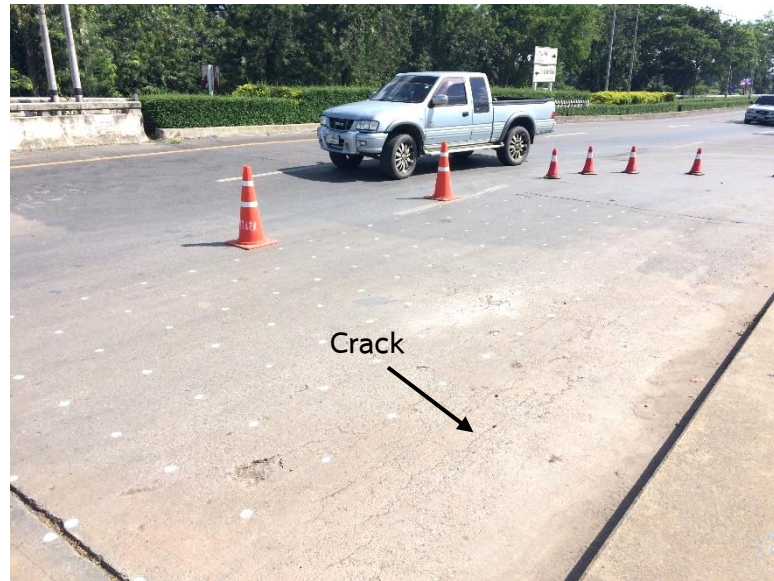
Figure 14 Longitudinal and transverse cracks on bridge deck

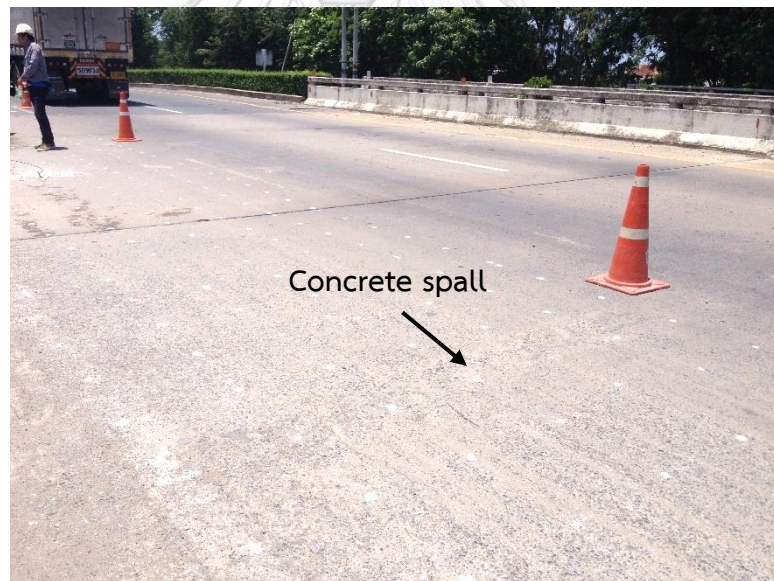
Figure 15 Concrete spall on the middle bridge span

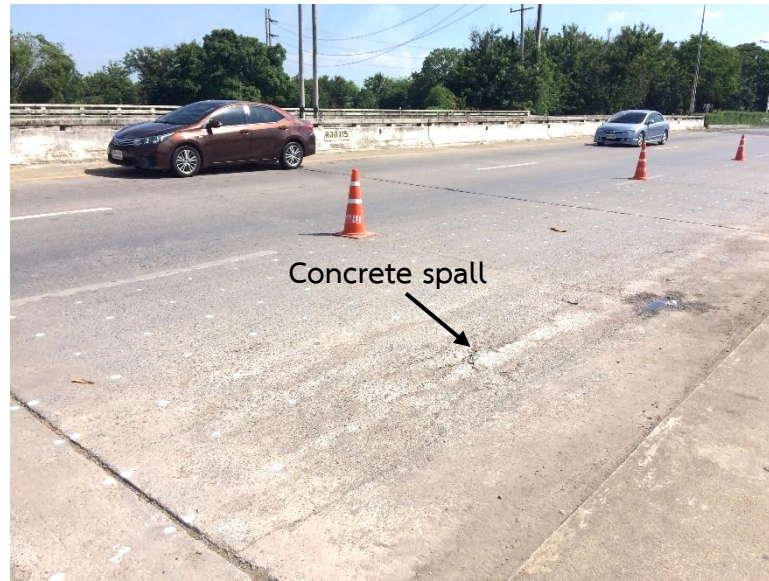
Moreover, other damage i.e. concrete scaling and pothole was also observed as well (Fig. 16).

Figure 16 Concrete scaling on along wheel path

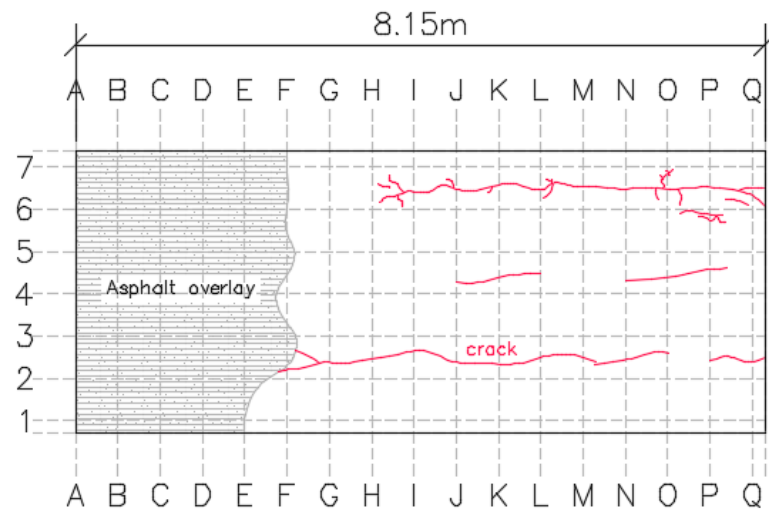
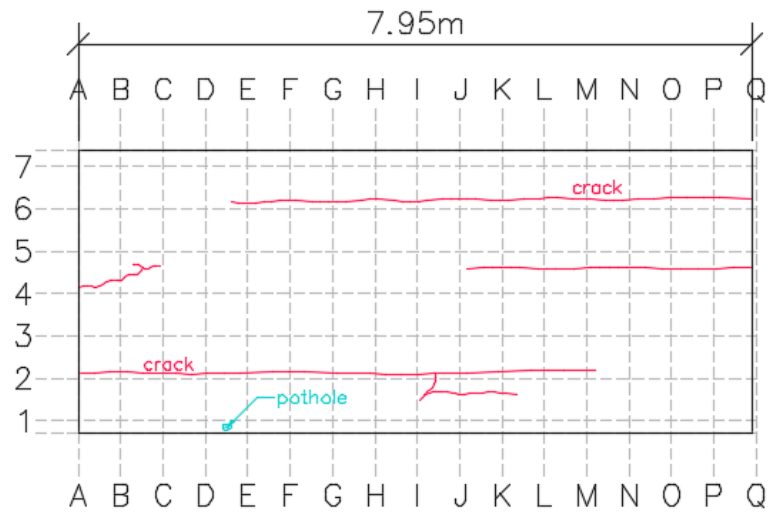
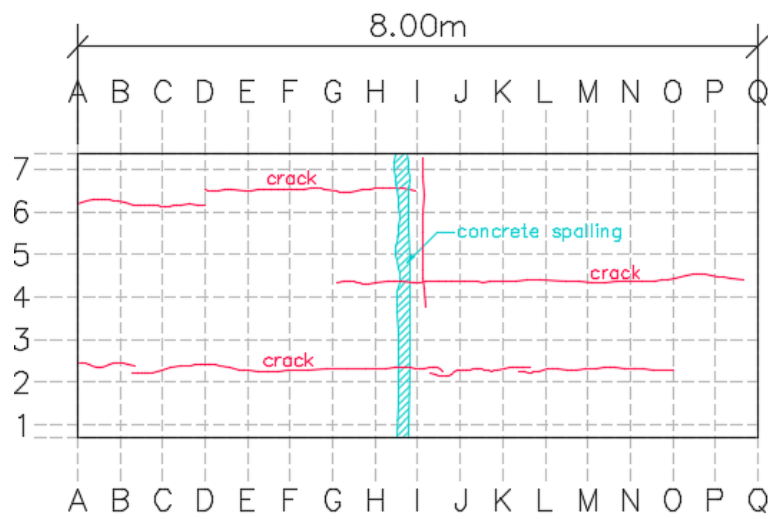
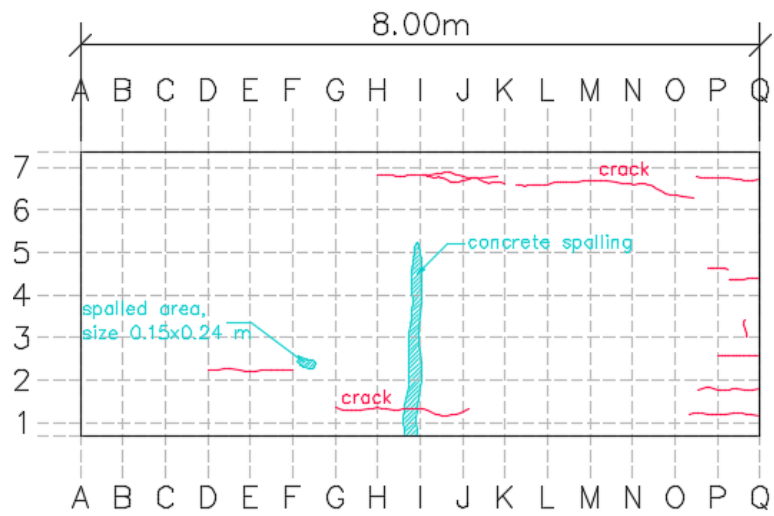
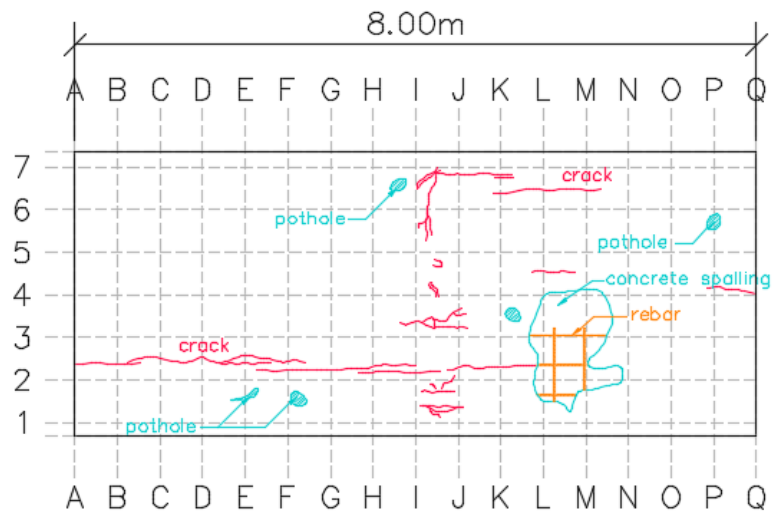
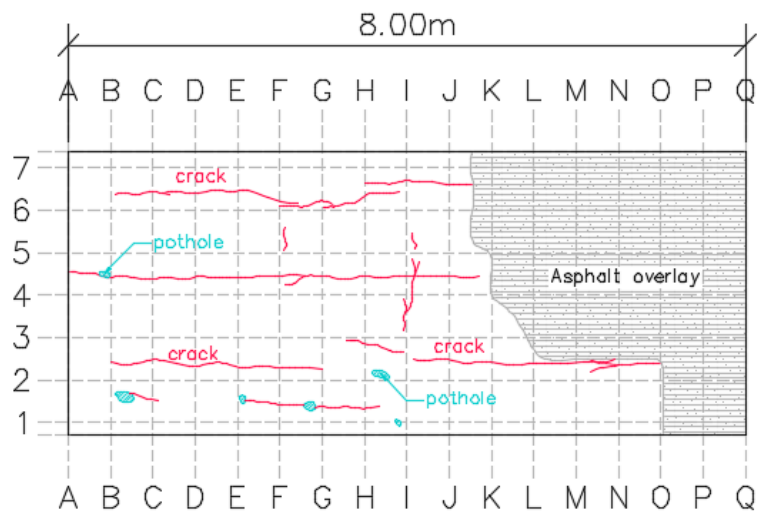
The damage location based on visual inspection on each section was shown in Fig. 17-25.

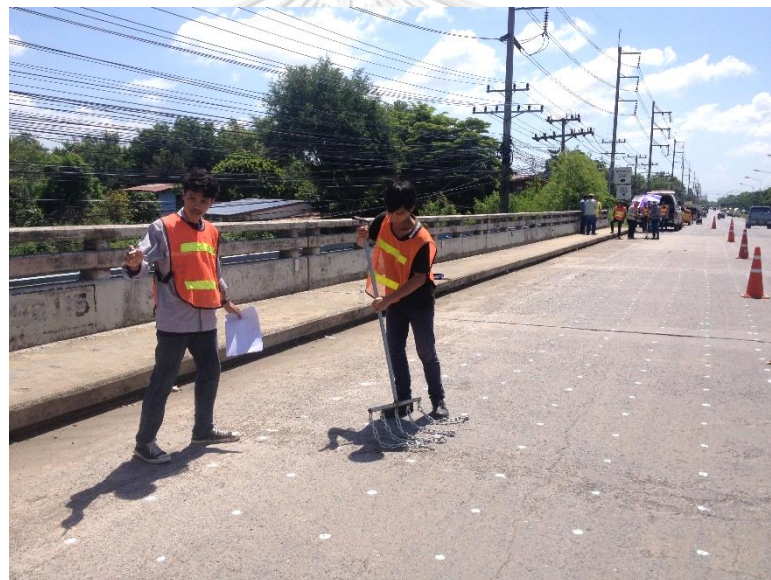
Figure 26 Chain drag test on bridge deck

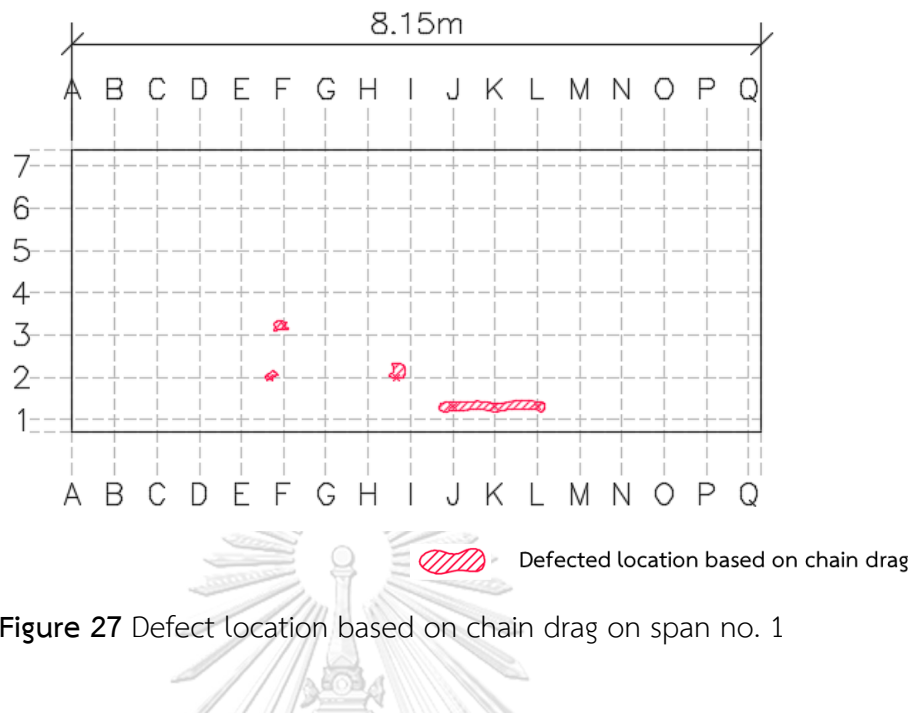
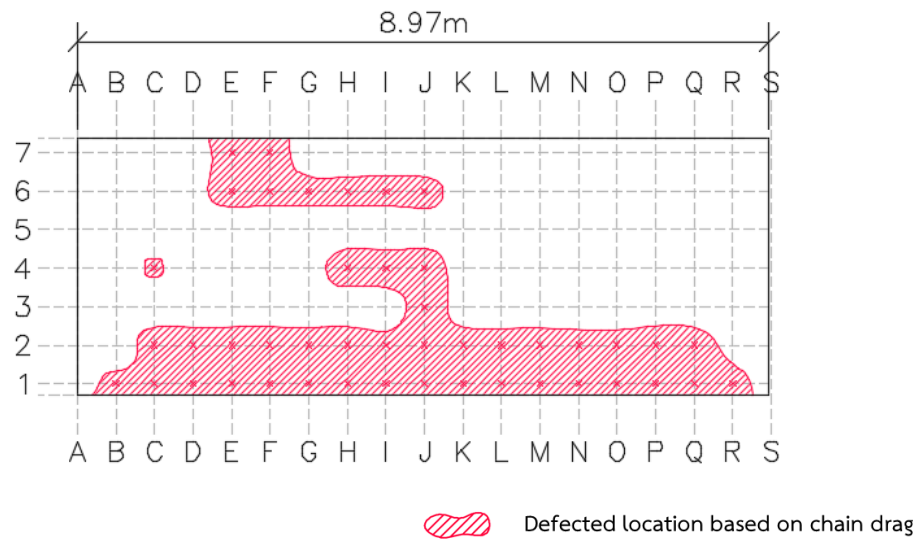
Survey results from each area (Fig. 27-35) shown that damage in concrete bridge deck were scattered in to span no. 3, 4, 7, 8 and 9. Concrete defect covered wide area. However, mostly damage found on left wheel path of traffic lane. In addition, concrete defect also found in transvers direction, clearly visible at span no. 4, 5, 6 and 8. For concrete defect on right wheel path also found that there is little damage.

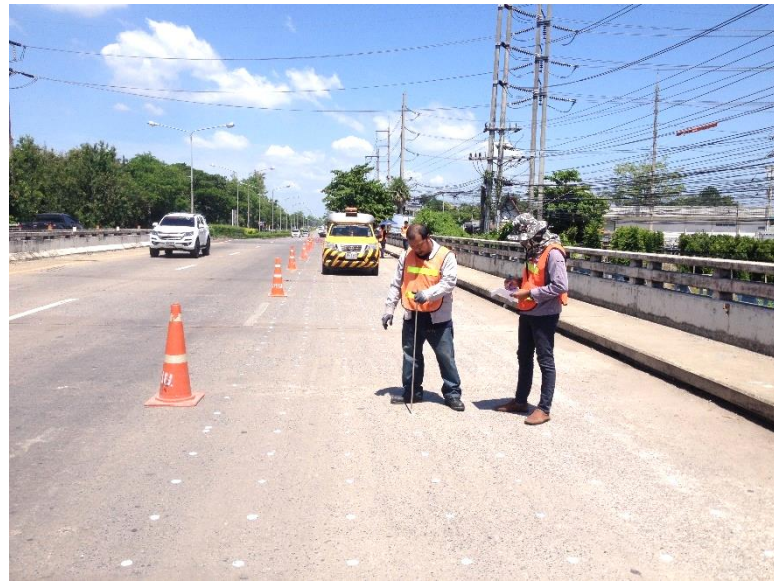
Figure 36 Sounding test on bridge deck

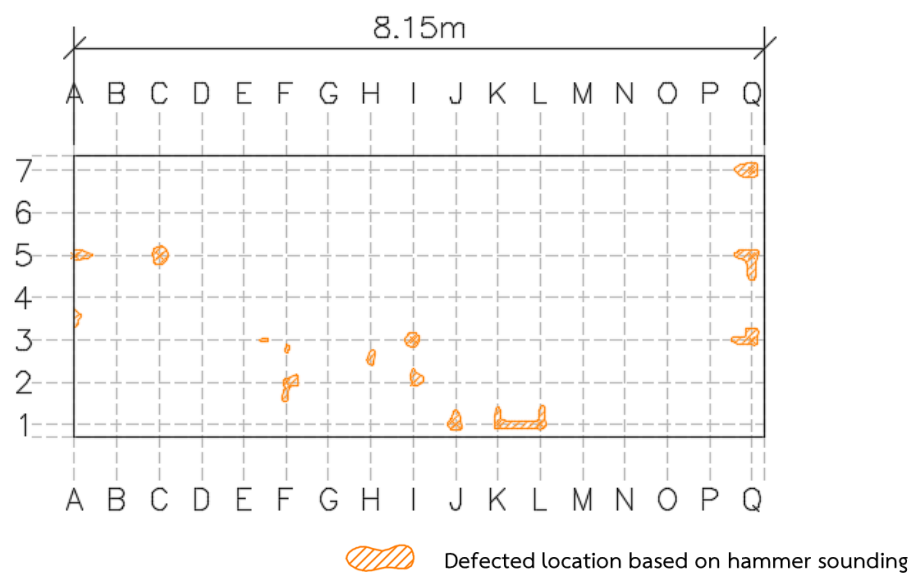
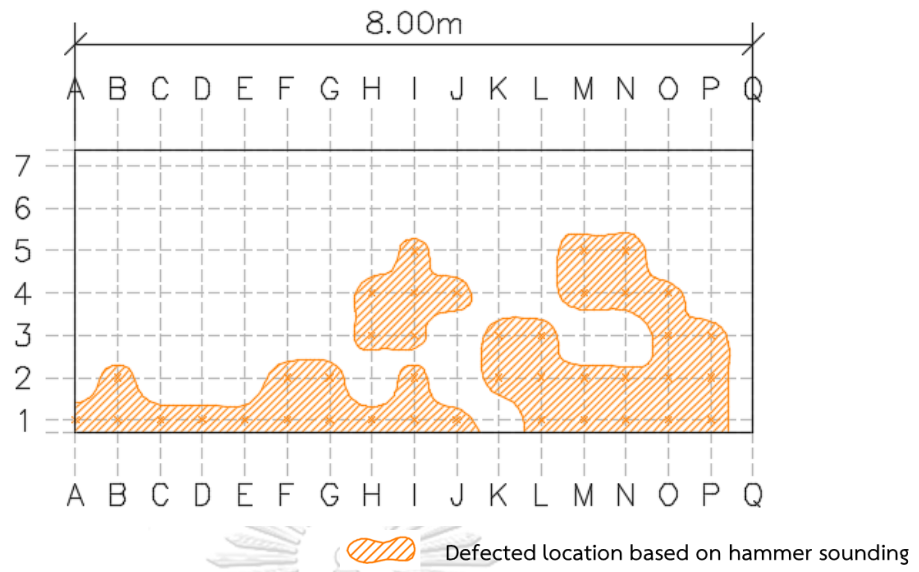
The results of hammer sounding (Fig. 37-45) found that the damage usually found in bridge span no. 3, 4, 7, 8 and 9 or about 20-30% area of bridge surface. In addition, defect in bridge deck also found in 0.50-1.00 meters size.

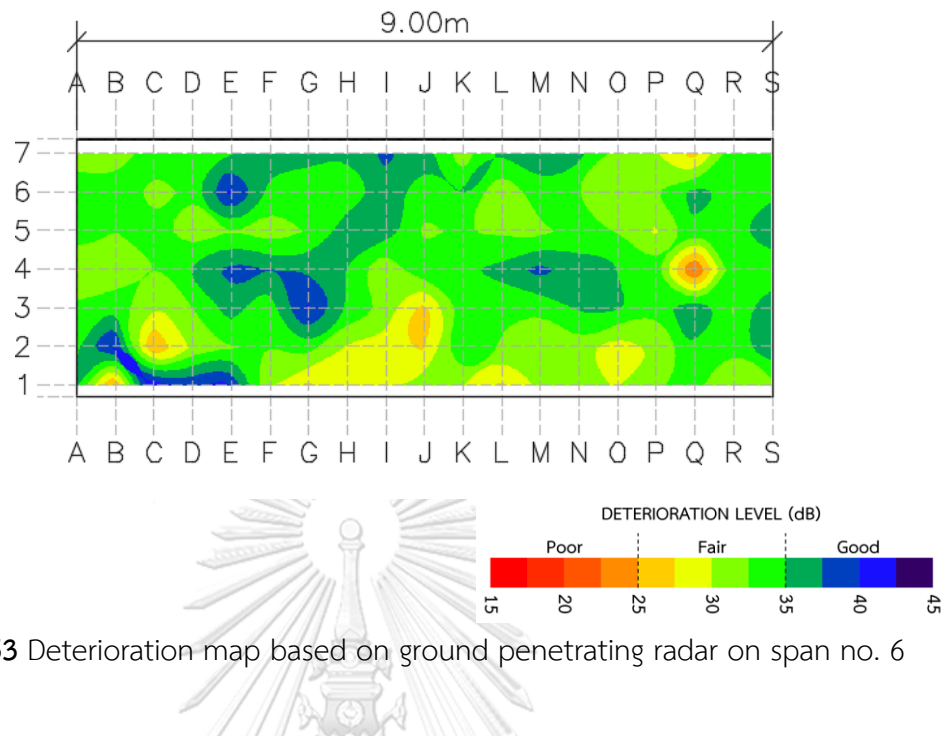
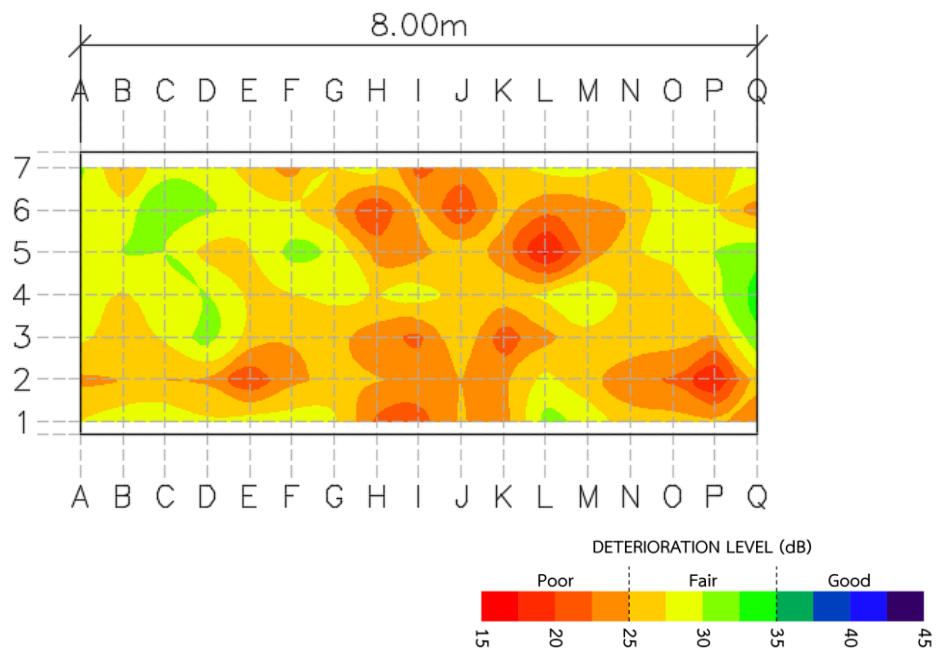
- (3) Deterioration amplitude less than 20 dB. This area with low amplitude may be have more corrosion in reinforcing steel as classified as poor condition for concrete bridge deck. Steel surface may be found corrosion.

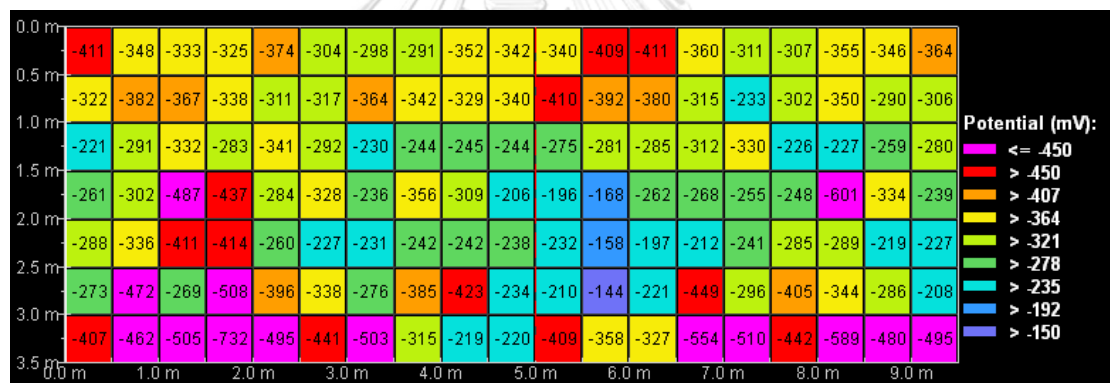
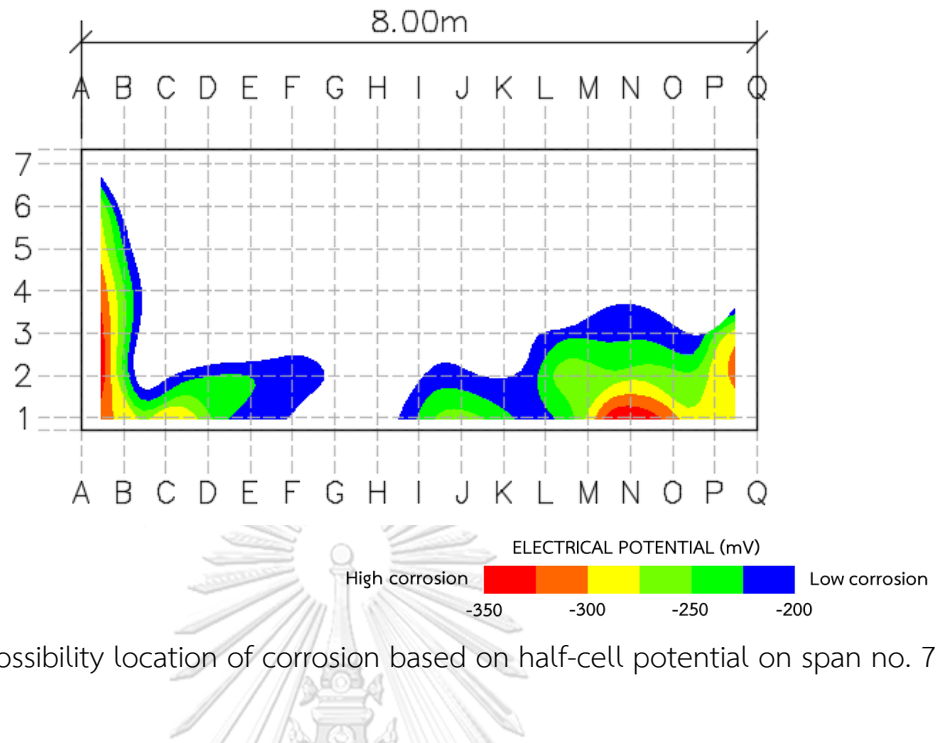
According to the survey results, it was found that bridge with high deterioration of steel are found in bridge span no. 4, 6 and 8, or exceeding 80% of the bridge deck. In addition, the bridge span no. 3, 5 and 7 also have possibility of corrosion in reinforcing steel as well. For another bridge span, possibility of corrosion in steel can be only found in small area.

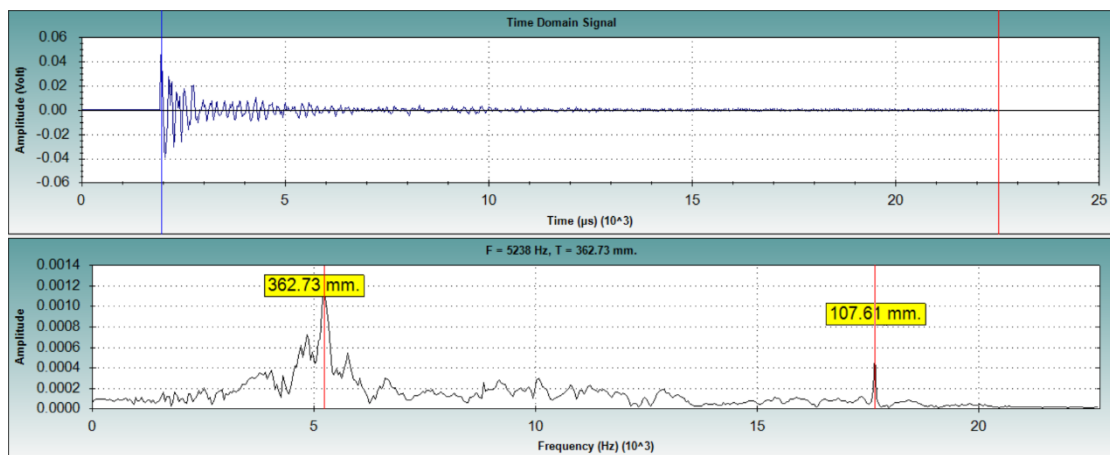
Figure 67 Example of impact echo test on bridge deck

The result of impact echo test by using hammer to generate stress wave (Fig. 67) compose of 2 graphs: (1) time domain result and (2) frequency spectrum result. Depth of anomaly can be found by convert from frequency value by specific stress wave velocity in concrete around 3,800 meters/seconds (calibrated velocity at know thickness portion). Details of significant reflection signal as follows: -

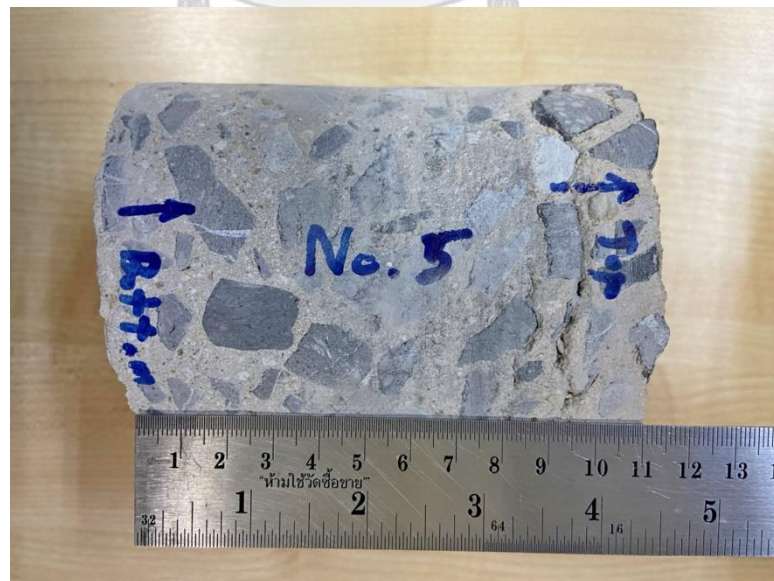
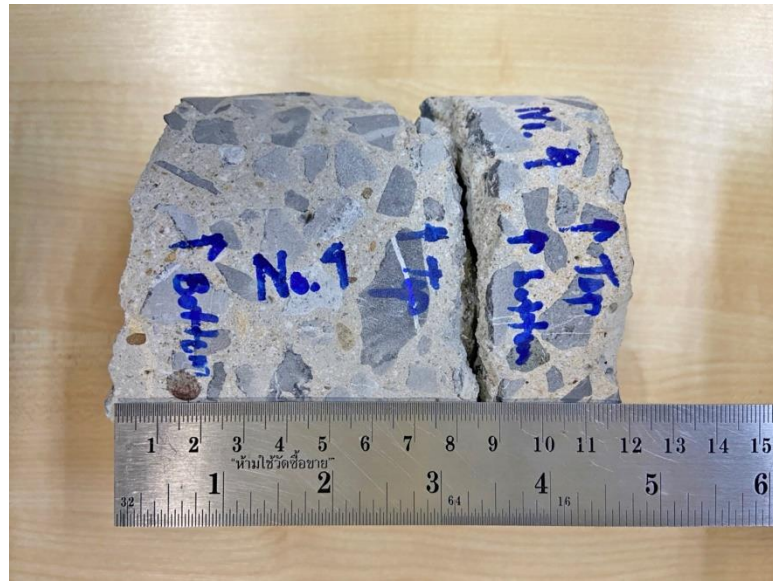
The results of drilling in the area where the crack was detected under the concrete surface at bridge span no. 4 gridline E/2 and bridge span no. 7 gridline E/2 by chain drag, hammer sounding and ground penetrating radar methods showed that the crack was found under concrete surface at 0.01-0.03 and 0.03-0.04 meters depth from bridge deck surface respectively as shown in Fig. 79-80.

Figure 79 Concrete sample located on bridge span no.4 gridline E/2

Figure 80 Concrete sample located on bridge span no.7 gridline E/2

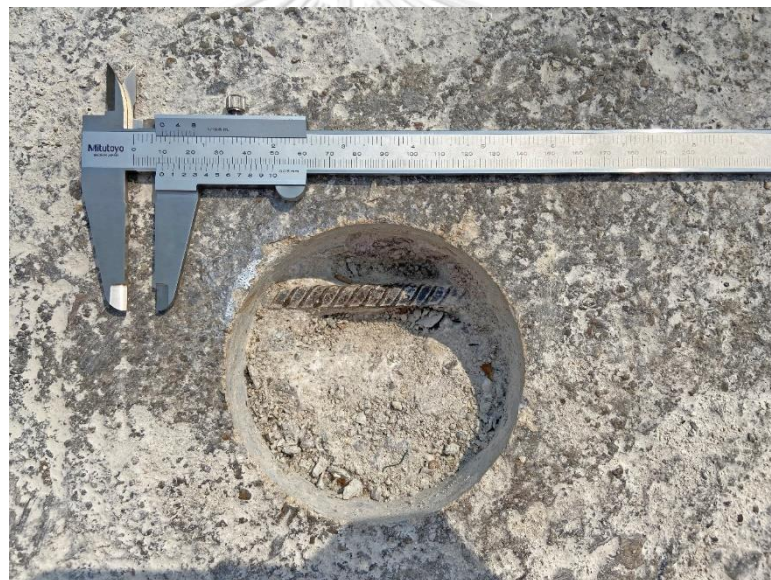
Figure 82 Steel surface on bridge span no. 1 at gridline I-J/3

- (1) According to electrical potential less than -350 mV, as shown in red area, steel sampling was be done on bridge span no. 1, 3 and 8 and gridline I-J/3, K-L/1 and H/3 respectively. Characteristic of steel was found a rust on most part of steel surface as shown in Fig. 82-84.
- (2) For electrical potential more than -200 mV, as shown in white area, steel sampling was excavated on bridge no. 5, 7 and 9 at gridline N-O/5, L/5 and E/4 respectively. Steel corrosion was observed on small area as shown in Fig. 85-87.
